Reprinted from *CoatingsPro Magazine*  
September 2002.

# Vapor Trails

## Battling Water Vapor in Concrete

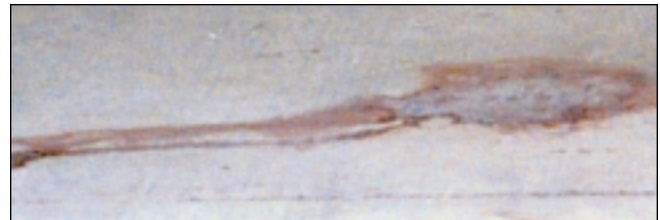
Transmitted water-vapor damage is evident in concrete (top) even after the original overlay was removed. But modified epoxy penetrates deep below the surface (above), creating a barrier that stops vapor and strengthens the concrete. When compatible polymer systems are used, the overlay and concrete become a monolithic structure.

Epoxy formulas used as vapor barriers are near the consistency of water when applied. They are applied directly onto the cleaned concrete surface with squeegee and rollers. The modified epoxy penetrates into the cement and fills voids and micro cracks in the area of treatment. Typically, a single application is sufficient to stop vapor transmission with rates up to 14 lbs. / 1,000 ft<sup>2</sup>. A second application of product has been shown to stop vapor transmission at rates up to 19 lbs. / 1,000 ft<sup>2</sup>. The drawback is that these vapor-stopping systems cannot be used as wear surfaces and require the appropriate overlayment to protect them.

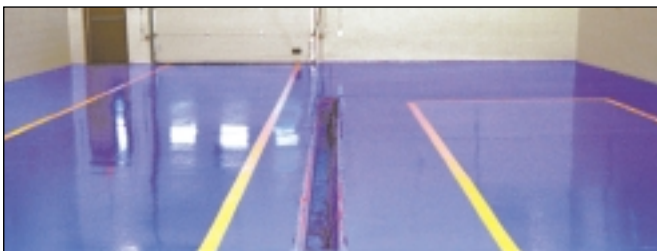
With vapor barrier laid, aggregate is broadcast, followed by an intermediate pigmented polyurea coating and clear skid-resistant topcoat. Concrete substrate, vapor barrier, and wear surface now combine to create a protective floor system.
